Inspection #4947S

Building Condition Report Of 101 Bittancourt Road, Salt Spring Island, B.C. V8K 2K2

Prepared for: Lady Minto Hospital Foundation

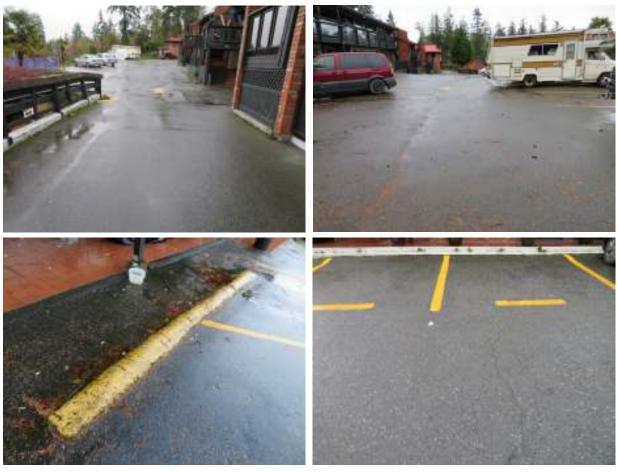
The property has a one-way paved asphalt driveway running through the lot with customer parking part way down both sides of the driveway and it is in fair to fairly good condition with some typical stress cracks and minor damage here and there. The parking lot has built up asphalt curb stops in front of the building that do not appear to be very affective with such a low profile a vehicle can easily drive over the curb and should be replaced with higher curbs. The painted parking lot lines have been recently re-painted.

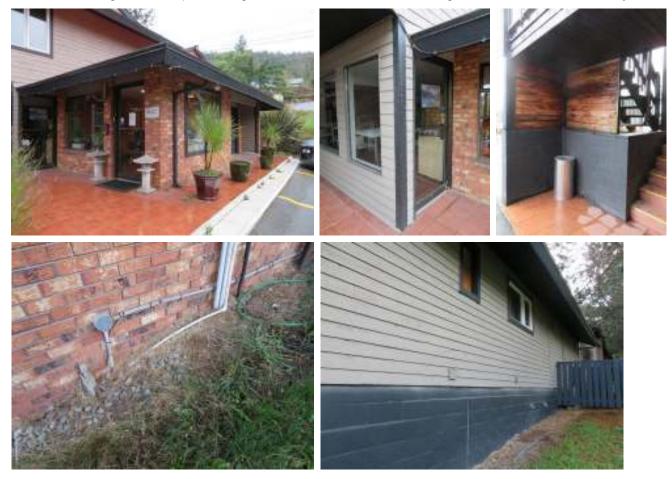
The exterior siding materials on the building is a combination of brick veneer siding, horizontal wood siding and a paint finish on the exposed concrete block walls. The brick veneer siding is in fair to fairly good condition with minor damage on a few bricks to be repaired, and moss growth on some areas of the mortar to be removed and repointed if necessary. The wood siding is in fairly good condition with typical wear and tear. The paint finish on the concrete blocks is in fairly good condition with no visible peeling or blisters. Sections of the brick siding is in contact with the soil and is required to have a clearance of between 150 mm and 200 mm (6"-8") from the ground to the bottom of the siding to prevent moisture damage. The south end of the building has some plant overgrowth to be cut back and the siding refurbished where necessary.

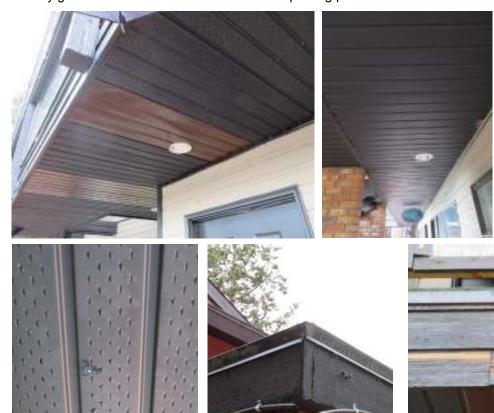
The building has perforated metal soffit finish installed throughout that is in fair to fairly good condition with some minor dents and typical damage, and some sections that have been replaced. The soffits on the second floor have water seeping through them from overflowing gutters allowing water into the concealed soffit spaces. The wood fascia boards are in fair to fairly good condition with isolated areas with peeling paint to be removed and refinished.

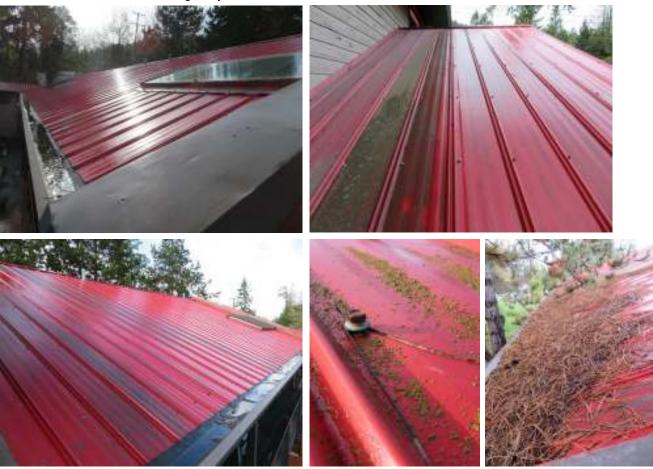
The roofing on the building is the original metal panel roofing material that is in fair to fairly good condition with no visible dents, damage or patches noted. The roofing material is estimated to be 38 years old with an expected service life of 50 years, so this roof should have another 12 years of service life remaining with proper maintenance and occasional repairs. The fasteners on this type of roof typically need replacement halfway through its expected service life and these fasteners on this roof need to be reviewed and replaced where necessary. The property has mature pine trees growing on the west side of the property and has branches growing over the roof, leaving a large amount of needles on the roof and gutters to be removed and cleaned out regularly.

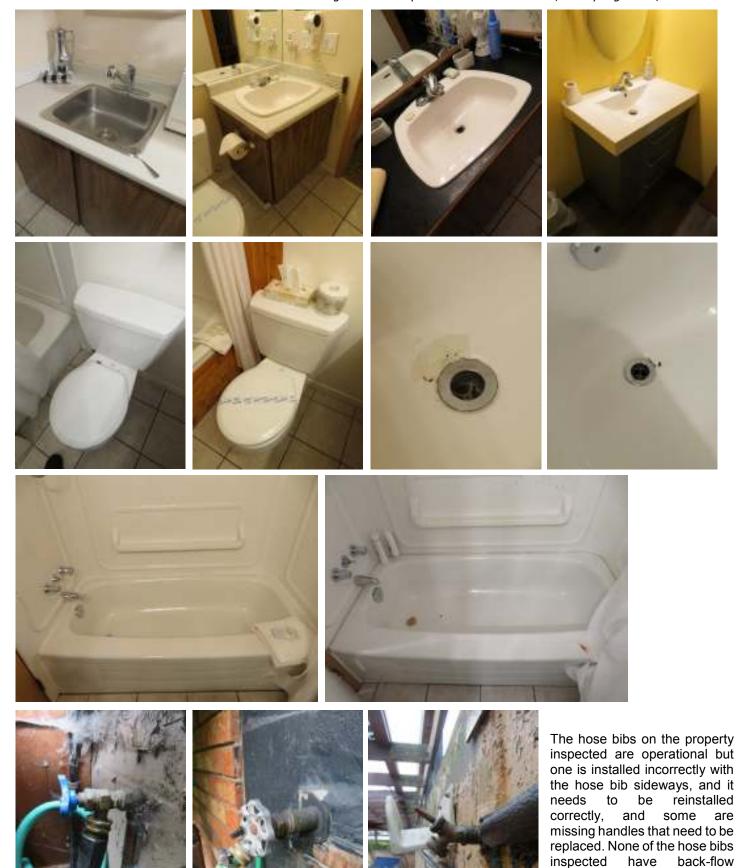
The various faucets and fixtures include stainless-steel kitchen sinks, porcelain and enamel bathroom sinks, toilets, and bathtubs. The laundry rooms have one plastic sink. The various faucets and fixtures inspected are in fair to fairly good condition with some chipped enamel fixtures to be repaired or replaced. Not all toilets are secure to the floor and some need to be re-secured. The breakfast service room has a small kitchen that is a converted washroom, and the toilet flange was not noted and should be reviewed to ensure a proper cap and seal.

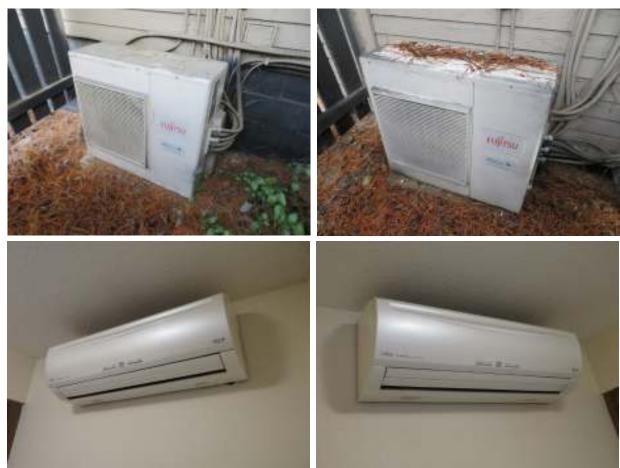
The building has four ground mounted electric powered "Fujitsu" split heat pump systems with interior wall mounted heating and cooling units in the guest rooms with the exception rooms 102 & 103 which have wall mounted "Sanyo" heating and cooling unit along with electric baseboard heating in the guest rooms and throughout the building. The "Fujitsu" exterior and the interior "Halcyon" inverters are in fair to fairly working good condition with no visible damage and typical wear and tear. These units are not manufacture dated and are estimated to be between 18 and 20 years old, and have an expected service life of 20 years so replacement of them should be anticipated within the next 3 to 5 years.
